## **Why Do PVC & CPVC Pipes Occasionally Fail?**

*By Dr. Duane Priddy, Plastic Failure Labs, Midland, MI*

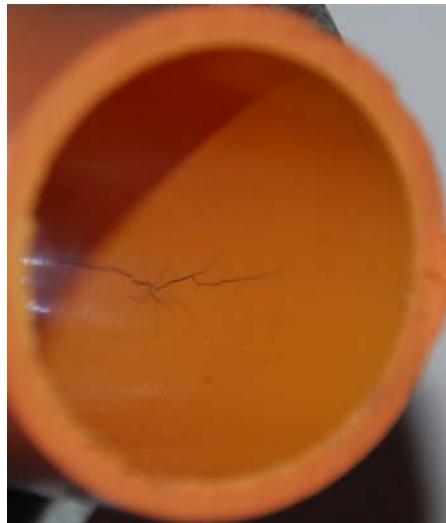
Plastic Failure Labs is an independent forensic laboratory. We have been conducting forensic failure analyses of plastic parts for several years. We have carried out hundreds of forensic failure analysis investigations of CPVC and PVC pipes and fittings at the request of insurance companies, installers, pipe manufacturers, general contractors, condominium associations, and private owners. We have found that the overwhelming/most common cause of failure is improper installation practices. Sometimes installation errors result in contamination, although these two issues are not always related. The combination of pipes under stress plus the exposure to incompatible materials, can lead to environmental stress cracking failure or ESC. This is especially the case with CPVC sprinkler system piping if not adequately flushed as recommended in NFPA 13 to remove debris and trace chemicals. If CPVC fire sprinkler systems are not flushed, trace chemicals remain trapped inside for periods of time and may become absorbed into the CPVC. CPVC is a very ductile material. However, the combination of prolonged high stress and absorption of certain hydrocarbon contaminants may cause it to weaken and develop stress-cracks (Figure 1).

**Figure 1.** Formation of a stress-crack on the inside of a CPVC fire sprinkler pipe at a point where a tight-fitting clamp was used.

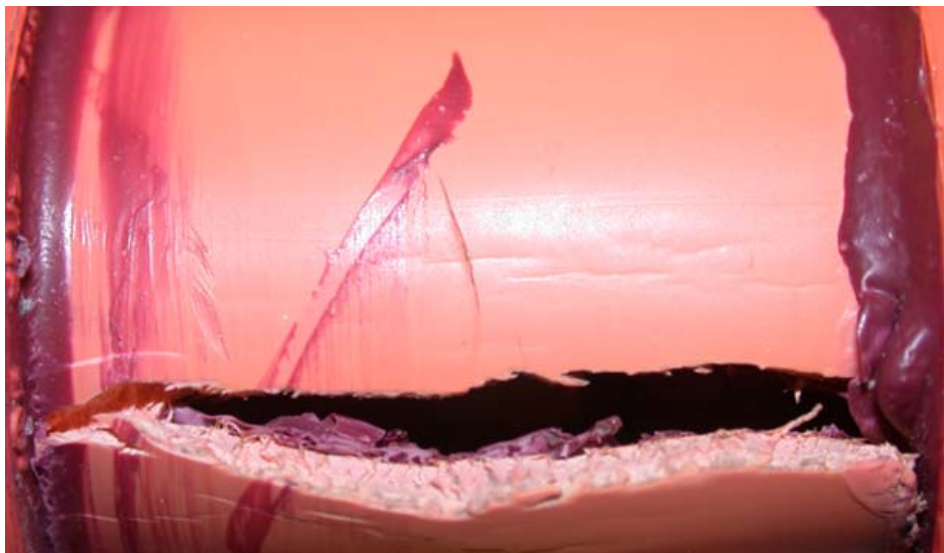
Excessive cement use: An installation problem that we occasionally see is the use of excessive cement. The solvents in the cement themselves are readily absorbed into CPVC and PVC; i.e., they readily are absorbed into the wall of the pipe and inside fitting socket resulting in solvation/softening of the material. Figure 2 shows a short piece of pipe with a fitting on each end having excess cement puddled inside the short piece of pipe. The solvents in the cement absorbed into the pipe wall resulting in softening of the pipe wall to the point that the pipe wall became swollen/softened and no longer had sufficient strength to hold water pressure resulting in blowout.

**Figure 2.** Puddling of excess cement inside of fitting ran into adjacent pipe resulting in softening and blowout of the pipe wall.

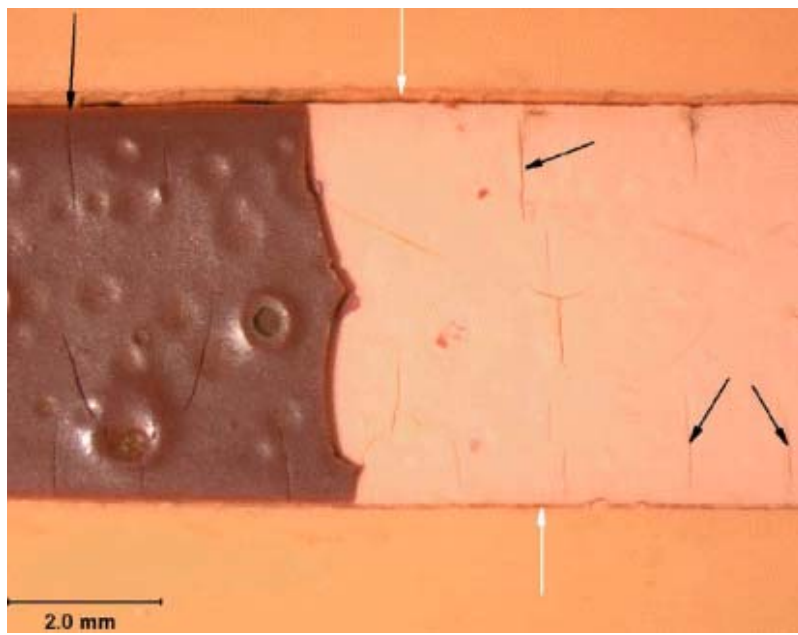
However, absorption of the solvents in the cement into the top layer of plastic in the pipe and fitting socket is necessary to achieve good bonding. The organic solvents in cement soften the surface of the pipe and fitting socket allowing the polymer molecules to intertwine to form a permanent bond. The organic solvents in the cement are volatile and quickly evaporate so that they are only around long enough to do their intended job but not long enough to cause the pipe to weaken. The problem is that occasionally installers utilize too much cement resulting in dribbles running down the inside of vertical runs of pipe. We have observed environmental stress cracks (ESC) both underneath (Figure 3) and adjacent (Figure 4) to cement dribbles. It is not known for certain exactly why ESC failures of pipes occasionally occur underneath or adjacent to cement dribbles. One theory is that the cement is porous and absorbs trace hydrocarbon contaminants present in the water and facilitates their absorption into the wall of the pipe. Another theory of the ESC cracking of CPVC immediately adjacent to a cement dribble is that the drying/shrinkage of the cement creates adjacent stresses on the inside surface of the wall of the pipe.

**Figure 3.** ESC of the inside surface of the wall of the pipe underneath a cement dribble

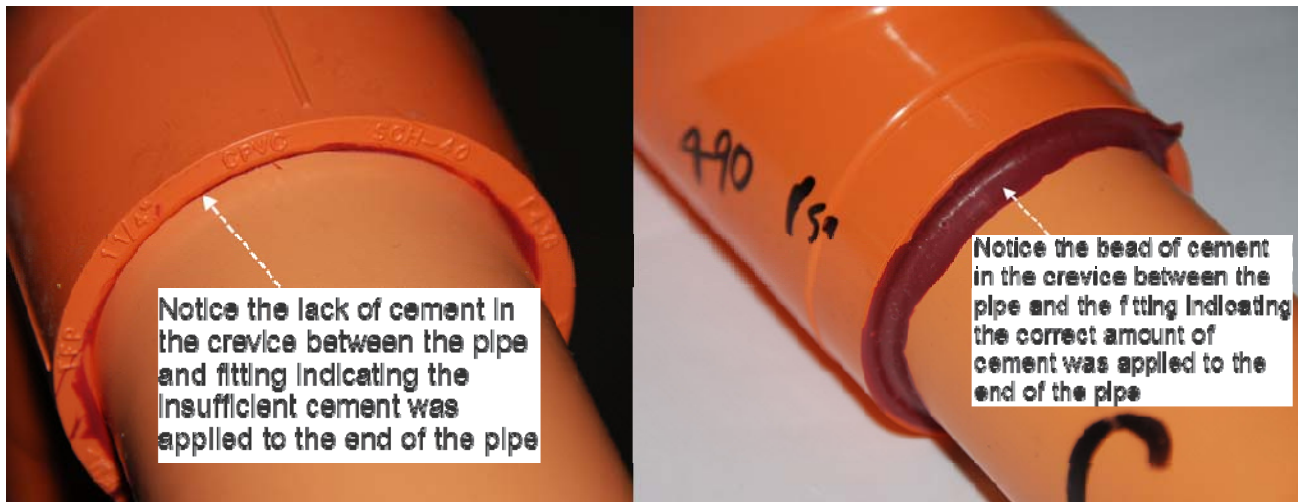
When excessive cement is used on the outside of pipe it is not as much of a problem as on the inside. This is because, on the outside, the volatile organic solvents quickly evaporate. However, on the inside of the pipe, the organic solvents are trapped allowing more exposure time of the inside wall of the pipe to the solvent. By applying the excess cement to the end of the pipe, but not the fitting, when the pipe is inserted into the fitting, the excess cement is pushed down the outside of the pipe forcing the excess to the outside of the pipe. If excess cement is applied to the inside of the fitting, the excess ends up remaining trapped inside the fitting and either puddles inside the fitting or else runs down the inside of the pipe (Figure 4). It is generally quite easy to spot whether a fitting was assembled using a sufficient amount of cement by simple examination of the cement residue in the crevice between the fitting and the pipe as shown in Figure 5.

**Figure 5.** Photos showing the external appearance of a bad (left) and a good (right) joints.

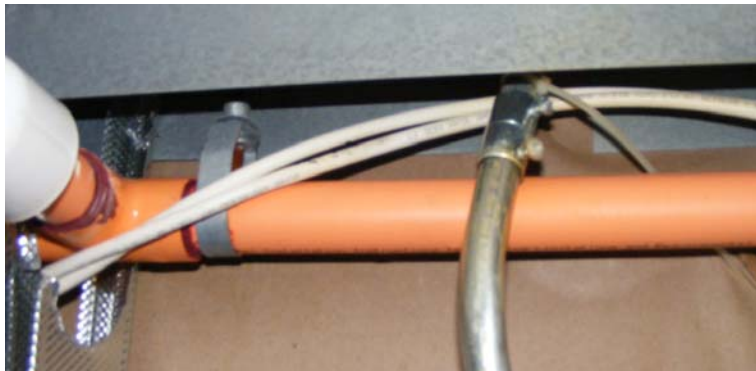
Incorrect Clamps and Contact with Conduit/Wire: Another very common cause of occasional failure is the use of the wrong type of support which places stress on the pipe. Also bending conduits around PVC or CPVC pipe can place high localized stress on the PVC/CPVC pipes in contact with the conduit. Some electrical wires, especially computer cables, should not be allowed to come into contact with PVC or CPVC pipes because the outer flexible sheath may contain plasticizers which can migrate into the pipe resulting in weakening and failure of the pipe. Figure 6 shows a photograph of a CPVC fire sprinkler pipe installation revealing contact of the pipe with electrical wire and a conduit – both should be avoided.

**Figure 6.** Picture of installation showing direct contact of conduit and electrical wires with CPVC pipe.

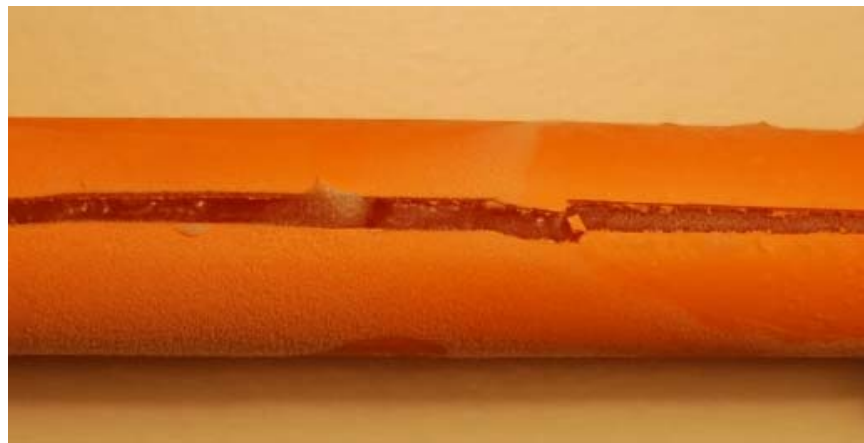
Diagnoses of the failure of CPVC pipes due to freezing is a challenge. If CPVC pipes break due to radial expansion of ice inside a CPVC pipe (Figure 7), diagnoses is quite simple because the pipe generally expands causing the wall thickness to decrease and go out of spec (Figure 8). However, researchers at the University of Illinois found that generally when pipes freeze, radial expansion is constrained by the pipe wall forcing the ice to expand longitudinally. The linear expansion of the ice causes a pressure build-up between the ice plug and the outlet or inlet valve. It is the high pressure that causes the failure. This discovery led them to receive several patents (US 5,730,168, US 5,785,072, and US 5,785,073) on devices that protect pipes from failure due to freezing.

**Figure 7.** Picture of frozen CPVC pipe.

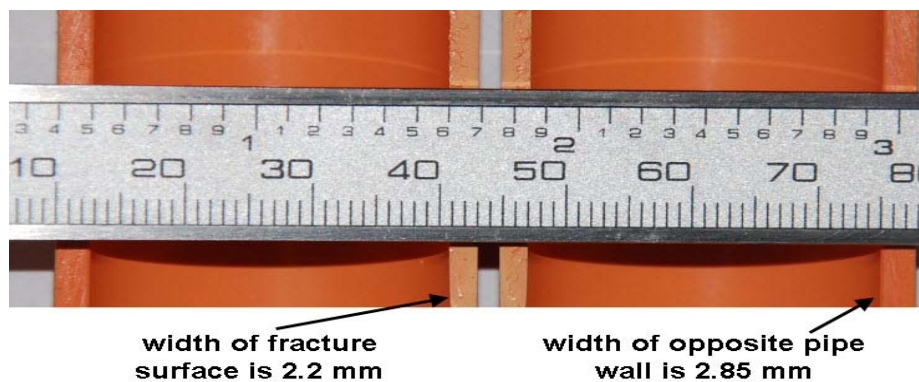
The frozen pipe shown in Figure 7 was thawed and then cut longitudinally in half by sawing through the pipe wall 180 degrees away from the fracture surface. Simply measuring the thickness of the pipe wall at the fracture surface and comparing the wall thickness 180 degrees opposite, reveals a large difference (Figure 8). The difference is caused by the slow tensile stretch and yielding/necking at the point of fracture. The yielding/necking at the point of fracture results in the thinning of the material at the point of fracture.

**Figure 8.** Wall thickness at fracture is significantly smaller than 180° opposite.

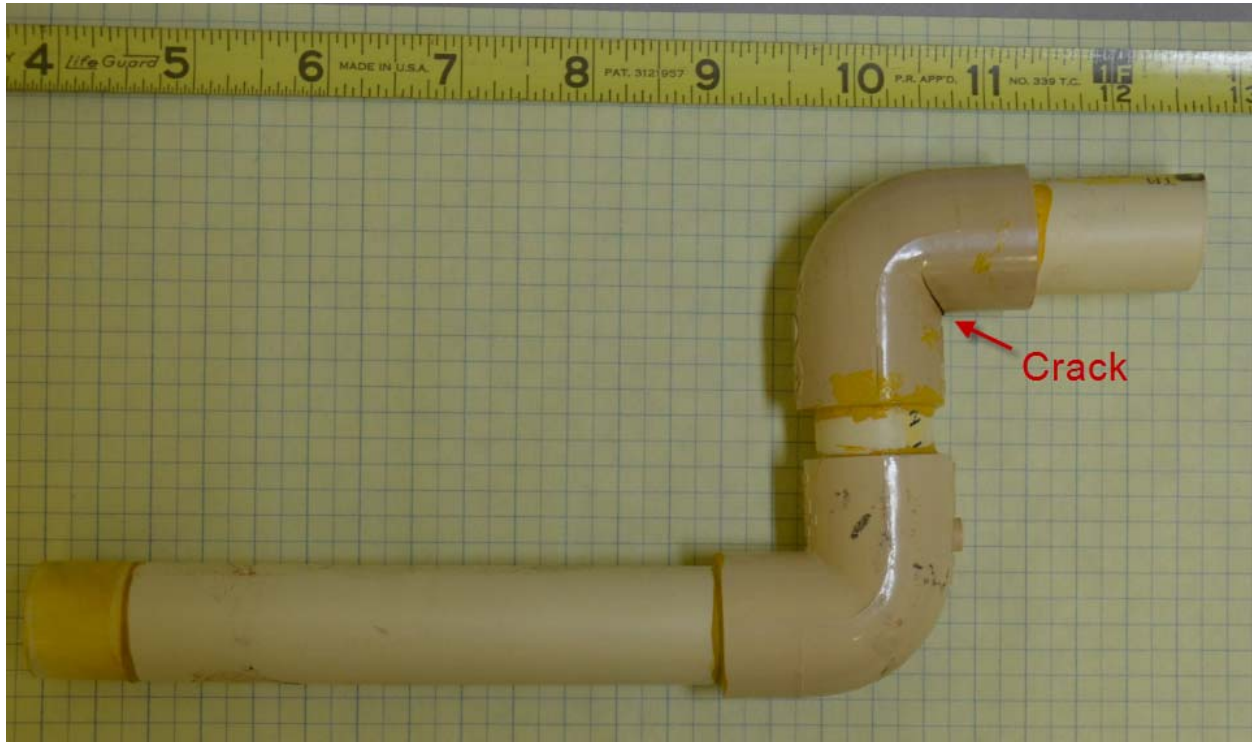
Pipe alignment: Pipes must be installed without excessive bending deflection stresses on the pipe. Pipe manufacturer's instructions should be followed regarding the maximum allowable bending deflections of their pipes. Excessive bending deflection may lead to failure of both the pipe and the fittings to which the pipes are connected. Elbow and Tee fittings are subject to creep failure in the crotch (Figure 9) if pipes are not installed in 90 degree alignment.

**Figure 9.** Pipes installed out of alignment placing high stress on the crotch of an elbow resulting in creep failure.

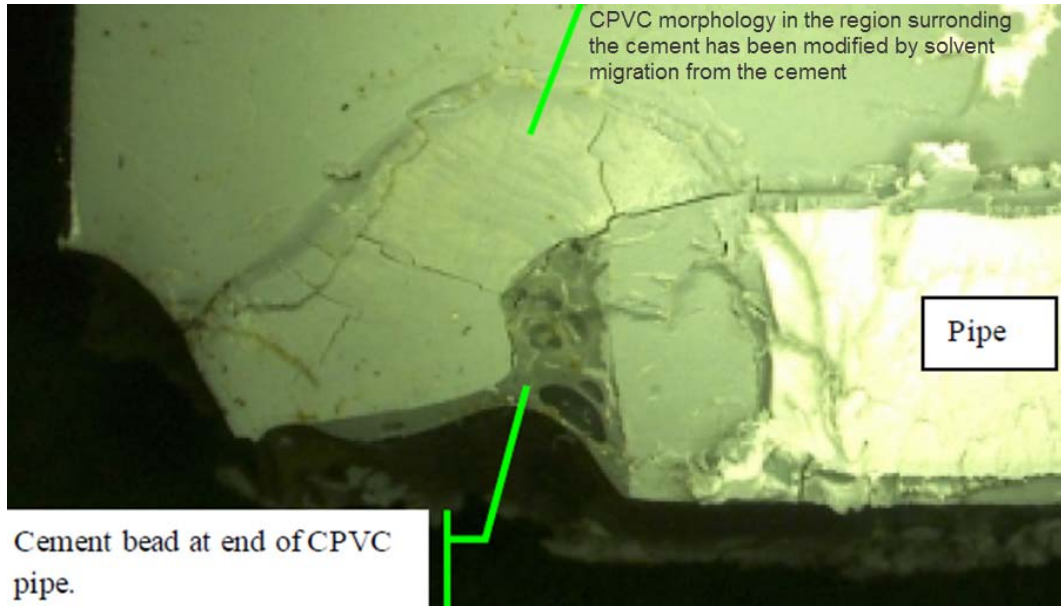
Short insertion: When PVC/CPVC pipes are inserted into fittings they should be inserted all of the way until the end of the pipe hits the stop. If they are short inserted, a pocket remains between the end of the pipe and the stop. This is a place where ESC failure may occur. The gap acts as a place where contaminants may accumulate and eventually ESC of the fitting take place. Recently we were involved in diagnosing the root cause of failure of two large hydronic heating systems having the recirculation loop constructed using CPVC pipes and fittings. Five fittings were received for forensic analysis. All five fittings failed in exactly the same way. The failure was initiated in the space between the end of the pipe and the insertion stop in the fitting. The failure mode was ESC. The heat exchanger leaked resulting in contamination of the recirculated water with refrigerant lubricant oil (polyol ester) which became concentrated in the short-insertion space causing failure of the fitting by ESC (Figure 10). We recently presented the results of our failure analysis at the Failure Analysis Division of the Society of Plastic Engineers Annual Technical Conference held in Boston, May 2011. A copy of the paper is available upon request.

**Figure 10.** microscopic view of the fracture surface of a fitting removed from a hydronic heating system. All of the fittings failed in exactly the same way; i.e., by absorption of lubricant oil from the refrigerant (due to a leak in the heat exchanger) into the pocket between the end of the pipe and the pipe insertion stop molded into the fitting socket.

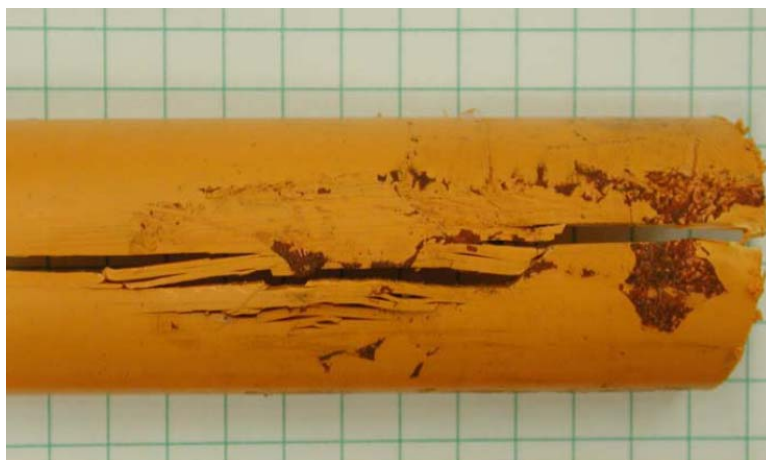
Contamination - Exterior: Care must be taken not to allow PVC/CPVC pipes to contact other materials that contain aromatic ester plasticizers and flame retardants. Figures 11 and 12 show examples of failure due to contact of CPVC with other materials that contain non-compatible plasticizers. Figure 11 was a pipe removed from a condominium where a worker sealed all of the openings in walls using a fire caulk that contained phthalate plasticizers. A drop of excess fire caulk fell down onto a CPVC fire sprinkler pipe. GC-MS analysis of the caulk and the failed pipe revealed the presence of phthalate ester plasticizers. Phthalate esters are highly incompatible with PVC/CPVC pipes.

**Figure 11.** Failure of CPVC fire sprinkler pipe underneath fire caulk that fell on the exterior surface of the pipe.

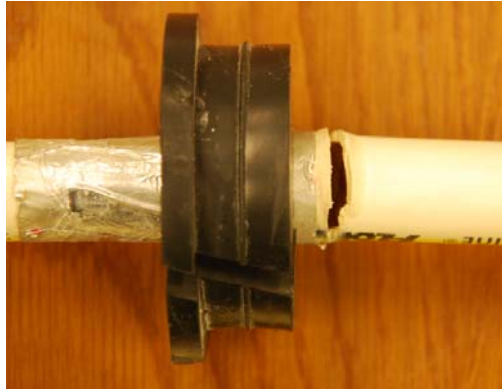
Figure 12 shows an example of the failure of a CPVC potable water pipe where a black grommet (Proset) that was used to seal a PVC/CPVC pipe penetration through a concrete floor. It was well known that Proset black grommets are not compatible with PVC/CPVC because they contain phthalate ester plasticizers so metal foil tape was applied to the pipe as a prophylactic to protect the pipe from chemical contamination by the phthalate ester plasticizers in the grommet. Metal foil tape will likely not be sufficient to stop phthalate ester plasticizers from migration from black Proset grommets. For the past few years, pipe manufacturers have strongly recommended against the use of such incompatible grommets and, as a result, ProSet now manufactures a white grommet which is compatible with PVC and CPVC pipes.

**Figure 12.** Failure of a CPVC potable water pipe due to migration of phthalate plasticizer from grommet down metal foil prophylactic used to protect the pipe.

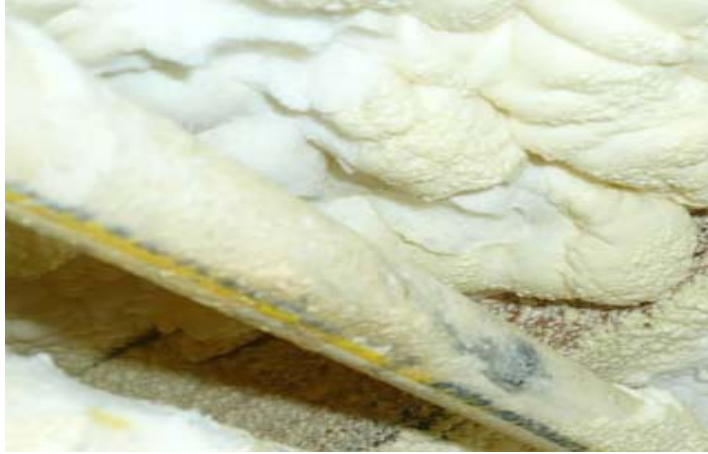
Polyurethane spray foam (PUSF) insulation can be a problem. PUSF generates heat as it cures. If the heat is trapped by a thick layer of foam against the wall of the pipe, the heat can weaken and distort the pipe. Also, each PUSF manufacturer has formulations that contain additives such as fire retardants. Some of these formulations may not be compatible with PVC/CPVC. You should consult with the PUSF manufacturer before applying PUSF in spaces where it may contact PVC and CPVC pipes asking them if for their assurances of the chemical compatibility of their product with plastic piping materials. The CPVC pipe shown in Figure 13 is cracked. Examination of the crack surfaces in the leaking pipe shown in Figure 13 showed ESC failure by migration of chemicals from the outside surface of the pipe (Figure 14).

**Figure 13.** CPVC pipe inside wall covered with PUSF.

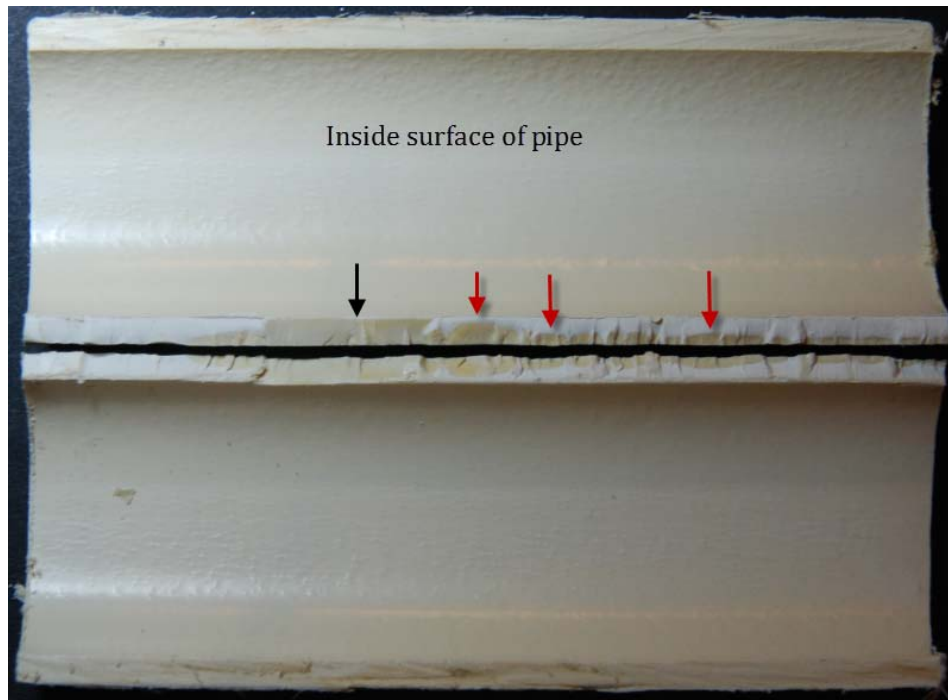
**Figure 14.** Close up view of the fracture surfaces showing distinctive thumbnail chemical penetration patterns from the outside wall of the pipe. Black arrow points to leak location and red arrows show thumbnail penetration zones that form as chemicals migrate into the outside wall of the pipe.

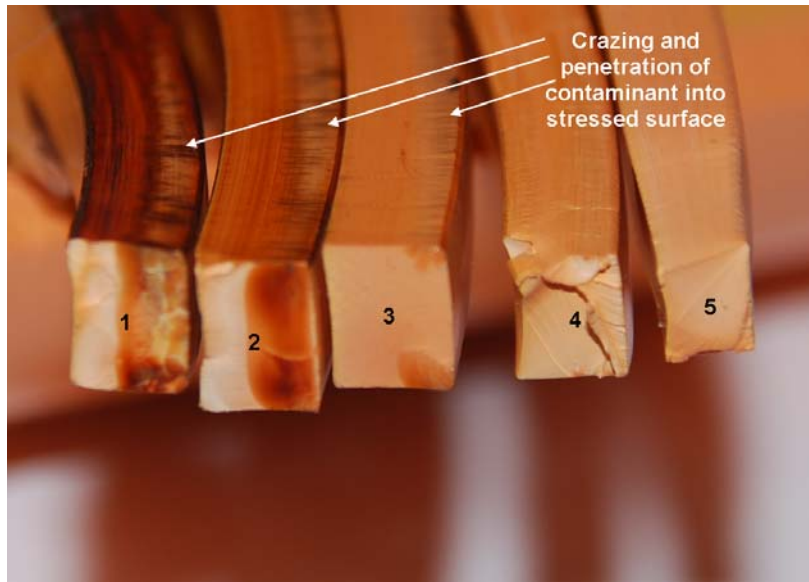
Some anti-MIC or antimicrobial linings in steel pipes may contain traces of water extractible chemicals that are not compatible with CPVC. Figure 15 shows the effects of water containing various trace levels of an amine (didecylmethylamine, a contaminant often found in ABF-2) and its quaternary ammonium salt form on CPVC test specimens. Notice the extensive crazing and discoloration of the treated test specimens down as low as 0.001% or 10 ppm of amine leads to chemical attack and weakening of CPVC. Currently there are some MIC inhibitor products that have been approved by Lubrizol as being compatible with their Balzmaster CPVC pipes. The list continues to grow as additional products are tested and approved. Since it is not a static list, we suggest that you refer to the Lubrizol website for the most updated list (see <http://www.lubrizol.com/BuildingSolutions/ChemicalCompatibility.html> ).

**Figure 15.** The effects (discoloration and crazing) of trace levels of chemical contaminants from ABF-II (amine and ammonium salt) on stressed CPVC test specimens. 1=0.1% amine in water, 2=0.01% amine in water, 3= 0.001% amine in water, 4=0.1% ammonium salt in water, 5=control.

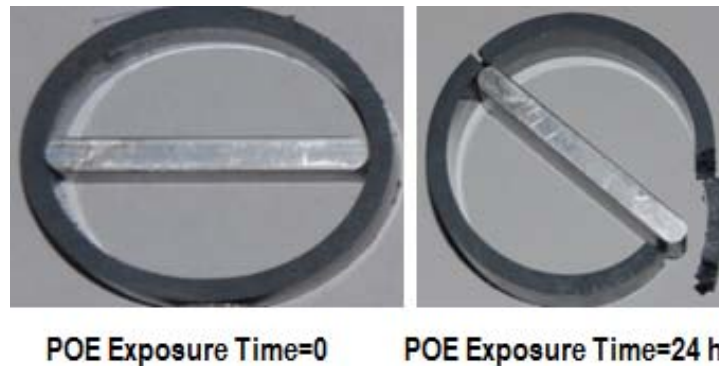
may become contaminated with the oil lubricant in the refrigerant. Back when CFC was used as the refrigerant, the lubricant was mineral oil. When a leak occurred, no PVC or CPVC failure occurred because mineral oil is compatible with both PVC and CPVC. However, the change to HCFC refrigerants brought about the need to change to a more polar lubricant oil because mineral oil is not soluble in HCFC refrigerant. Most HCFC refrigerants utilize polyol ester oil (POE) as the lubricant. Unfortunately, POE oil is highly incompatible with PVC/CPVC (Figure 16) and leaks in heat exchangers can cause failure of the PVC or CPVC piping system (Figure 10). There is a need for hydronic heating system manufacturers to develop alternative refrigerant lubricants that are compatible with PVC and CPVC.

**Figure 16.** Exposure of a CPVC pipe test ring under stress becomes brittle after only a few hours of exposure to POE.

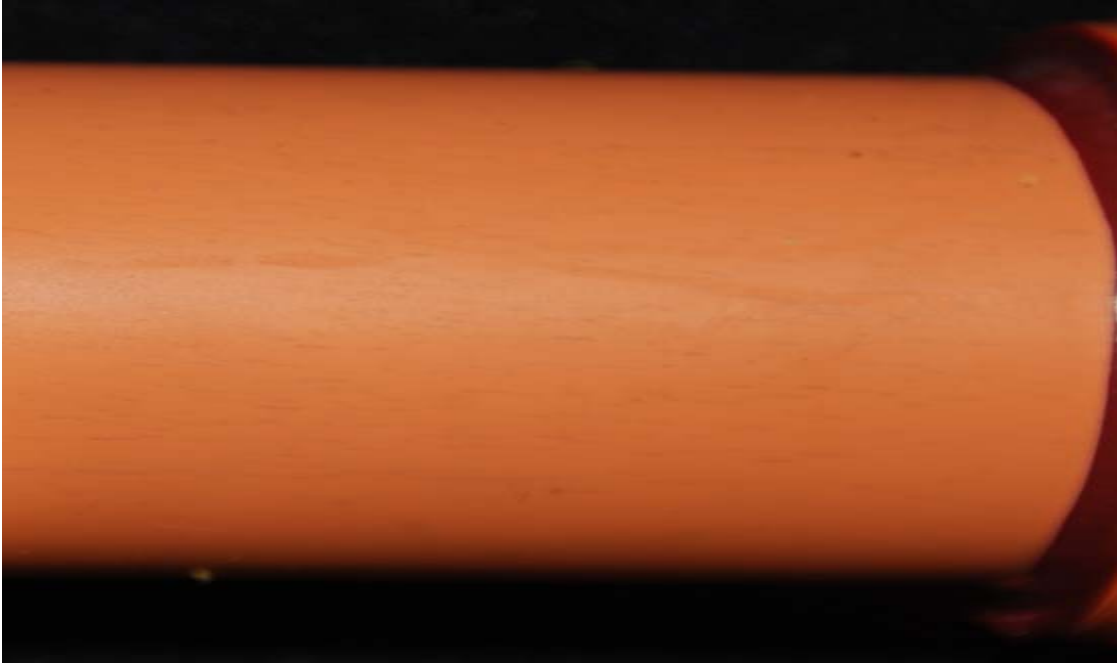
The manufacturing process of CPVC pipe is highly regulated with numerous required tests and standards. Plastic pipe is manufactured by extrusion of molten PVC/CPVC resin through a circular die with a mandrel held in place with thin metal vanes (often referred to as a “spider”). While passing through the die, the molten PVC or CPVC resin formulation is sliced by the mandrel vanes but then fuses back together again to produce a solid pipe. After the die, the pipe is cooled using a combination of air and water under controlled conditions so that the pipe does not end up with frozen in stresses which can affect the mechanical strength and chemical resistance of the pipe. Pipe defects, including residual stress, can result if the extrusion and cooling processes are not properly optimized. Pipes that contain high levels of frozen in stresses are like coiled springs looking for opportunities to relieve the stress. Stress relief can be achieved in several ways. One is by crazing which manifests itself by the formation of hundreds of tiny micro-cracks in the pipe wall. A pipe that has undergone extensive crazing in the pipe wall is shown in Figure 17. Extrusion lines (caused by a dirty die) create weak points in the pipe wall that are more susceptible to chemical attack resulting in failure by ESC. This mode of failure is indicated by the presence of perfectly straight parallel cracks running down the inside pipe wall (Figure 18). Pipes having these manufacturing defects are more susceptible to failure when exposed to water containing chemicals that are incompatible with the pipes and fittings.

**Figure 17.** Extensive surface crazing of outside pipe wall.

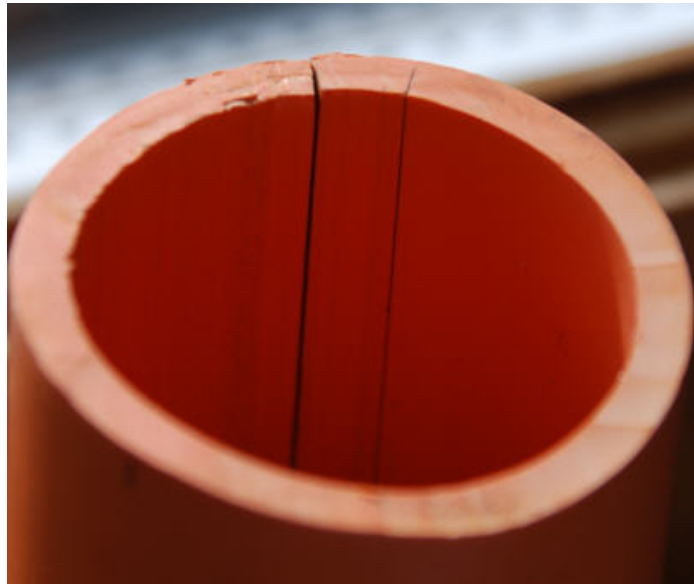
**Figure 18.** Weak extrusion lines (likely caused by dirty die) on the inside surface of a CPVC sprinkler system pipe resulting in the formation of parallel straight cracks upon exposure to water containing contaminants.
